## ROAD SAFETY ASSESSMENT

ANNAQUATUCKET ROAD  
NORTH KINGSTOWN, RI

Prepared by  
**Bowman Consulting Group, Ltd.**  
24 Albion Road, Suite 310  
Lincoln, RI 02865

SEPTEMBER 2025

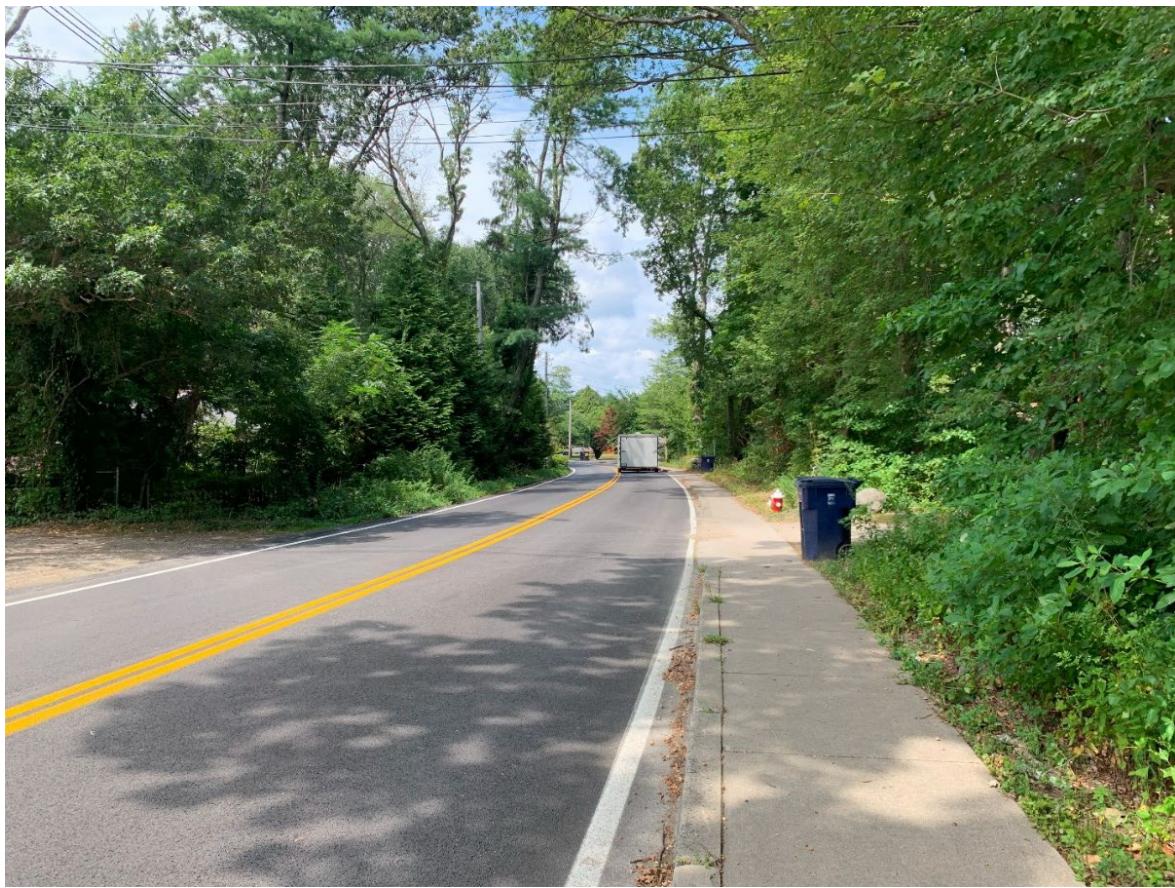
Annaquaticket Road between Fairway Drive and Lantern Lane, looking west

Annaquaticket Road is a frequently traveled collector connecting Tower Hill Road and Boston Neck Road (Rhode Island State Route 1A), two principal arterials that provide north–south connections through the town. Annaquaticket Road carries significant local and regional traffic, serving both as a connector route and as access to homes and schools.

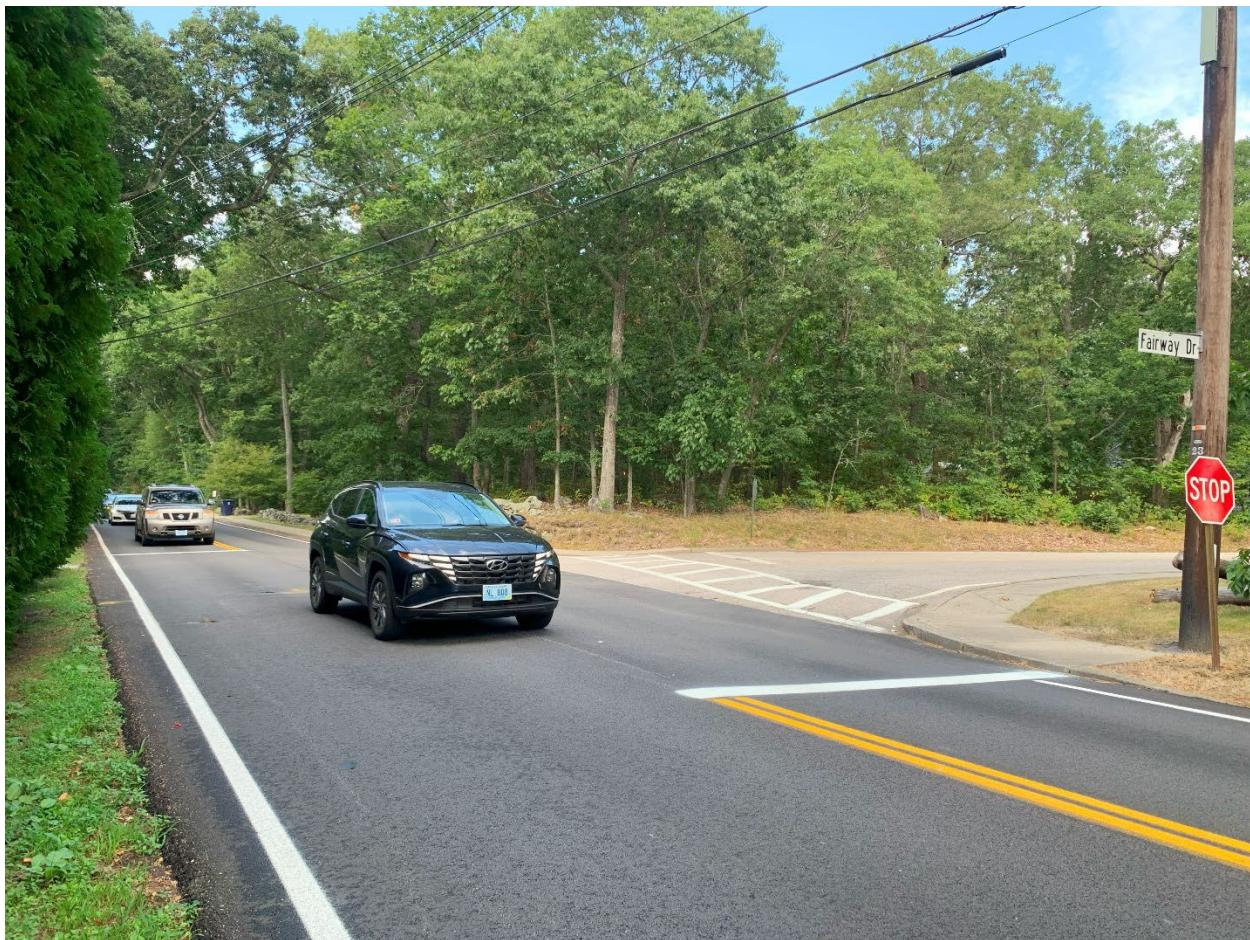
The three-way stop-controlled intersection of Annaquaticket Road and Fairway Drive is under Town of North Kingstown jurisdiction. It provides direct access to North Kingstown High School and North Kingstown Town Hall. There is a striped crosswalk across Fairway Drive, and striped stop bars, center lines, and edge lines on Annaquaticket Road.

Annaquaticket Road at Fairway Drive, looking northwest

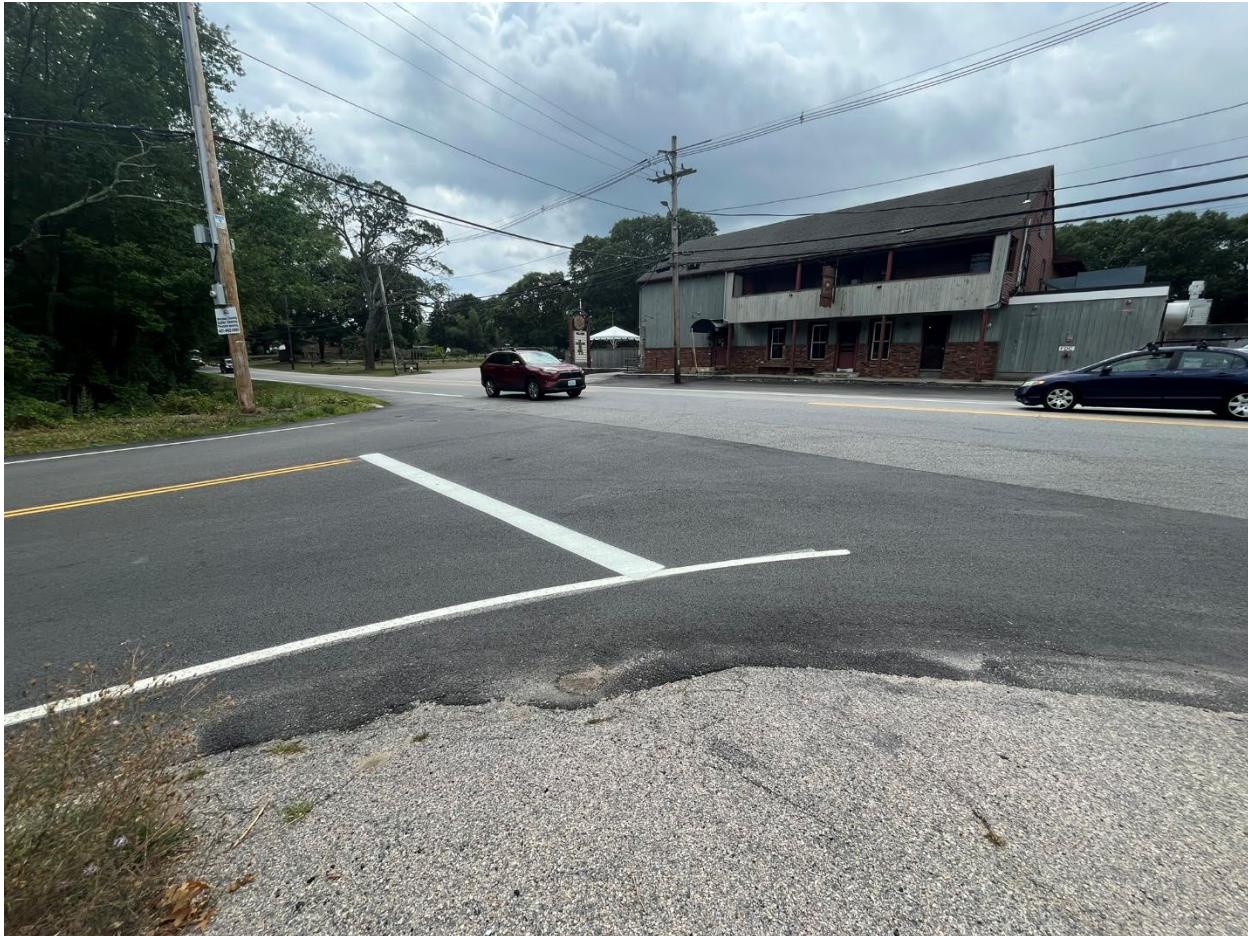
The unsignalized intersection of Tower Hill Road (U.S. Route 1), and Annaquaticket Road is under state jurisdiction. There is a stop sign on the Annaquaticket Road westbound approach to Tower Hill Road. There are no sidewalks, crosswalks, or curbing at the intersection.

Tower Hill Road at Annaquaticket Road, looking south

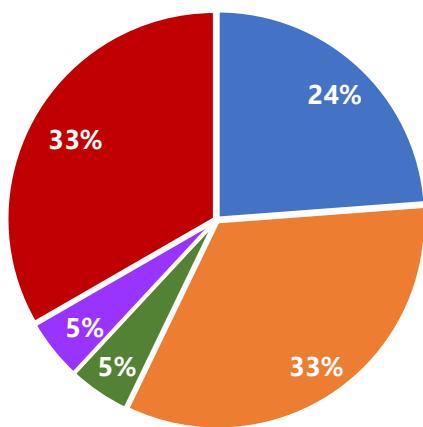
**Figure 2: Crash Type Summary for Study Area**

The Town of North Kingstown Police Department provided crash data for the study area. A total of 21 crashes were reported within the study area between 2019 and 2023, with **Figure 2** showing the various crash types. Rear-end and single vehicle collisions were the most common crash types (7 crashes each), followed by angle collisions (5 crashes), sideswipe collision (1 crash) and head-on collision (1 crash). **Figure 3** summarizes crash severity. A total of 5 crashes (24%) resulted in personal injury, while the remaining 16 crashes (76%) had no reported injuries. Of the crashes resulting in injuries, two were rear-end collisions, two were angle collisions, and one was a single vehicle collision.

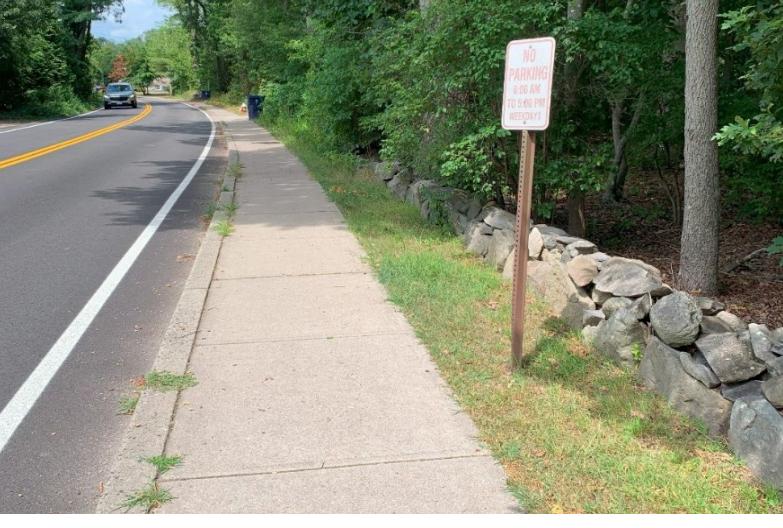
OBSERVATION	SHORT-TERM IMPROVEMENTS Under 6 months	MID-TERM IMPROVEMENTS Under 2 years	LONG-TERM IMPROVEMENTS Over 2 years
<p><b>Pedestrian Facilities and Accommodations</b> Sidewalks are present on the northern side of Annaquaticket Road from Fairway Drive to Amy Street. Sidewalks are approximately 4 feet wide. No other sidewalks are present in the study area.</p>

<p><i>Existing sidewalks on the northern side of Annaquaticket Road</i></p> <p>Curb ramps do not have detectable warning panels and are not ADA compliant.</p>

Safety Issue	Potential Safety Enhancement	Time Frame	Safety Payoff	Cost	Responsible Party
<b>Pedestrian Facilities and Accommodations</b>	Evaluate the potential for a crosswalk on Annaquaticket Road	Short-Term	Low	Low	Town
	Install crosswalks at locations identified under short-term improvements along with ADA compliant curb ramps	Mid-Term	Medium	Medium	Town
	Review the existing curb ramps on Fairway Drive to determine ADA compliance and replace as necessary	Mid-Term	Low	Medium	Town
	Install sidewalks along Tower Hill Road and along Annaquaticket Road east of Fairway Drive	Long-Term	High	High	RIDOT / Town
	Evaluate the feasibility of a shared-use path along Tower Hill Road and along Annaquaticket Road east of Fairway Drive, and construct if warranted	Long-Term	High	High	RIDOT / Town
<b>Bicycle Facilities and Accommodations</b>	Paint shared lane markings and/or install "Bikes Allowed Use of Full Lane" signage on Annaquaticket Road	Short-Term	Medium	Low	Town

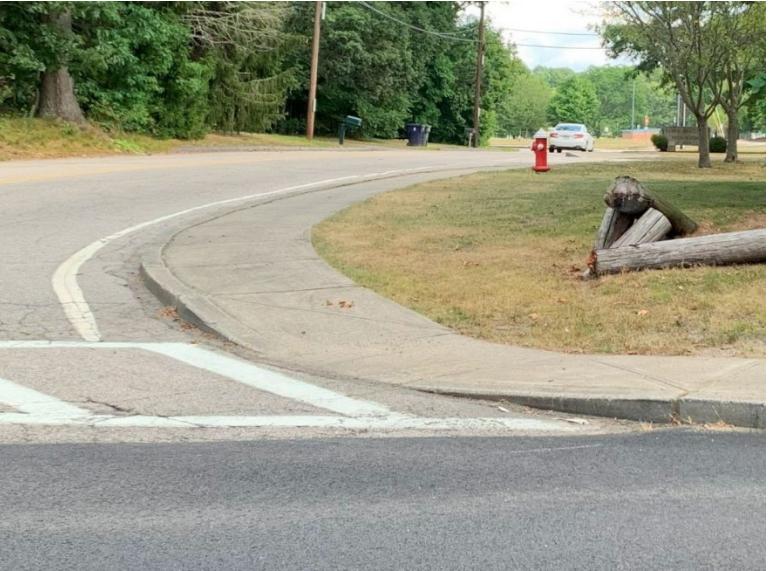
<p><i>Existing curb ramp at the Fairway Drive crosswalk</i></p> <p>The only crosswalk in the study area is across Fairway Drive. There are no crosswalks across Annaquaticket Road or at the Tower Hill Road intersection.</p>	<ul style="list-style-type: none"> <li>Evaluate desire lines for pedestrians crossing Annaquaticket Road; consider opportunity for a crosswalk</li> </ul>	<ul style="list-style-type: none"> <li>Install curb ramps with detectable warning panels compliant with the Americans with Disabilities Act (ADA) at the existing marked crosswalk across Fairway Drive</li> <li>Install painted crosswalks at locations identified under short-term improvements along with ADA compliant curb ramps</li> </ul>	<ul style="list-style-type: none"> <li>Install sidewalks along Tower Hill Road and along Annaquaticket Road east of Fairway Drive</li> <li>Evaluate the feasibility of installing a shared-use path along Tower Hill Road and along Annaquaticket Road east of Fairway Drive</li> </ul>

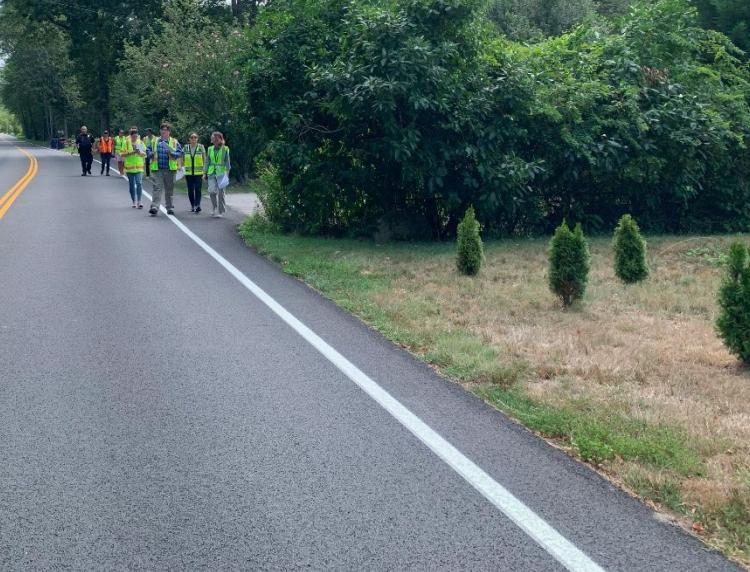
OBSERVATION	SHORT-TERM IMPROVEMENTS Under 6 months	MID-TERM IMPROVEMENTS Under 2 years	LONG-TERM IMPROVEMENTS Over 2 years
<p><b>Bicycle Facilities and Accommodations</b> There are no existing bicycle facilities in the study area. Narrow shoulders on Annaquaticket Road require bicyclists to ride in the travel lane with other vehicles.</p>

<p><i>Narrow shoulder on Annaquaticket Road</i></p>	<ul style="list-style-type: none"> <li>Paint shared lane markings (also known as "sharrows"), accompanied by "Bikes Allowed Use of Full Lane" signs (MUTCD R9-20) on Annaquaticket Road to indicate the presence of bicycles in the travel lane</li> </ul>	<i>N/A</i>	<ul style="list-style-type: none"> <li>Consider the feasibility of removing the sidewalk segment on Annaquaticket Road and installing a shared-use path to accommodate bicycles on the full extent of the roadway from Tower Hill Road to Boston Neck Road</li> <li>Install a dedicated bike lane on Tower Hill Road, separated by flexible delineator posts</li> <li>Consider the feasibility of installing a shared-use path on Tower Hill Road separated by curbing and/or a planted verge at least five feet wide</li> </ul>

Consider the feasibility a shared-use path on the full extent of Annaquaticket Road, and construct if warranted	Long-Term	High	High	Town
	Install a dedicated bike lane on Tower Hill Road, separated by flexible delineator posts	Long-Term	High	Medium/ High	RIDOT
	Consider the feasibility of installing a shared-use path on Tower Hill Road, and construct if warranted	Long-Term	High	High	RIDOT
<b>Intersection/Roadway Geometry</b>	Install flexible delineator posts on the shoulder on Tower Hill Road to prevent passing of left turning vehicles	Short-Term	High	Low	RIDOT
	Install striped median and flexible delineator posts on Tower Hill Road to prevent premature left turns onto Annaquaticket Road	Short-Term	High	Low	RIDOT

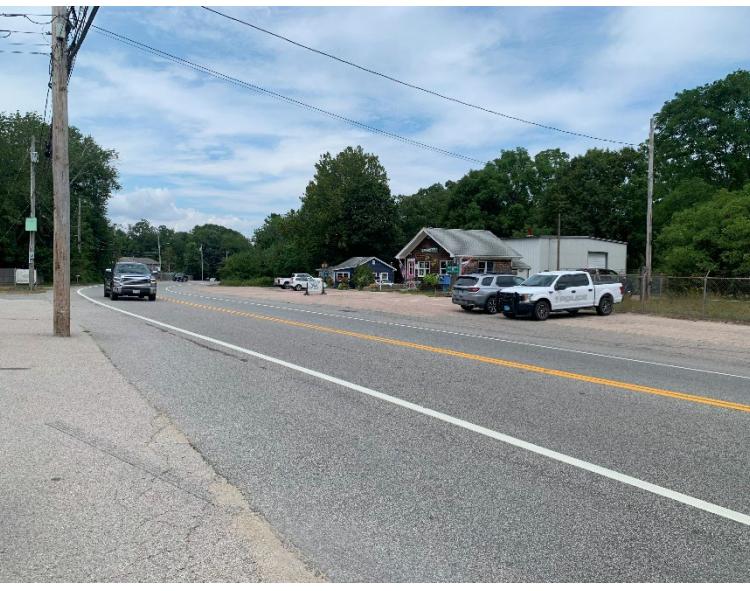
<p>Tower Hill Road has wide shoulders that could potentially accommodate bicyclists. However, due to high volumes, high speeds, and vehicles using the shoulder to pass turning vehicles, there are safety concerns for bicyclists.</p>

<p><i>Wide shoulder on Tower Hill Road</i></p>

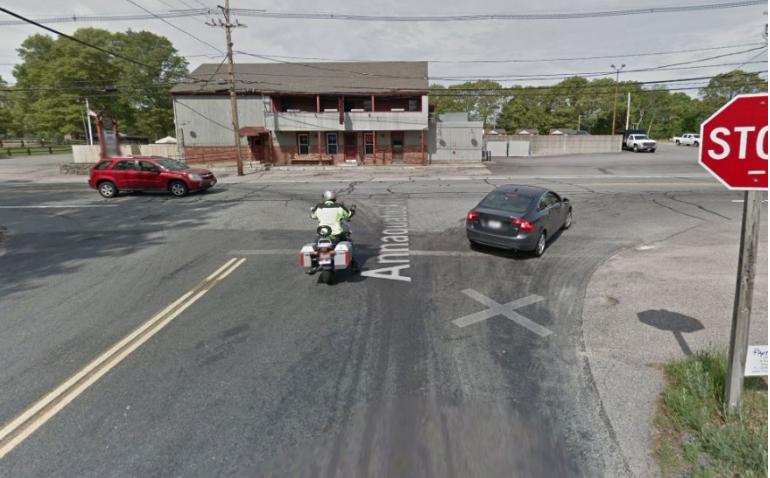
OBSERVATION	SHORT-TERM IMPROVEMENTS Under 6 months	MID-TERM IMPROVEMENTS Under 2 years	LONG-TERM IMPROVEMENTS Over 2 years
<p><b>Intersection/Roadway Geometry</b></p> <p>The existing geometry of the Tower Hill Road at Annaquaticket Road intersection leads to unsafe driver behavior, as southbound drivers on Tower Hill Road often use the wide shoulder to pass left turning vehicles, leading to potential conflicts with vehicles that are turning left out of Annaquaticket Road.</p> <p>The Tower Hill Road at Annaquaticket intersection has frequent "near miss" conflicts according to RSA attendees and evidenced by a near miss incident during the site visit, in which a southbound driver on Tower Hill Road turning left onto Annaquaticket Road narrowly avoided colliding with a heavy-duty truck turning left onto Tower Hill Road southbound from Annaquaticket Road westbound.</p> <p>Access management along Tower Hill Road is a concern, with no existing curbs and wide driveways for property access.</p> <p>The wide lane width on Annaquaticket Road westbound allows both left turning and right turning vehicles to stop simultaneously at the stop bar, creating sight line issues in both directions.</p>

<p><i>Wide lane width on Annaquaticket Road (image source: Google Earth)</i></p> <p>Speeding is a problem within the study area, as evidenced in the speed study and in observations during the field visit. The width of Tower Hill Road, including its wide shoulders and lack of sidewalks or curbing, encourages high vehicle speeds through the corridor, creating additional hazards at the Annaquaticket Road intersection. Team members noted that drivers coming from Oak Hill Road toward the Annaquaticket Road and Route 1 intersection are often traveling at high speeds.</p> <p>RSA team members noted that they often avoid the Tower Hill Road at Annaquaticket Road intersection when making local trips due to the observations noted above.</p>	<ul style="list-style-type: none"> <li>Install flexible delineator posts along the existing painted shoulder in front of Oak Hill Tavern to prevent southbound vehicles on Tower Hill Road from passing left turning vehicles on the right</li> <li>Install a striped median and flexible delineator posts on the Tower Hill Road southbound approach to prevent premature left turns onto Annaquaticket Road</li> <li>Narrow the width of Annaquaticket Road at the intersection with Tower Hill Road using paint and/or flexible delineator posts to ensure only one vehicle turns onto Tower Hill Road at a time</li> <li>Advance the Town's plans to implement speed cameras for speed enforcement within the school zone on Annaquaticket Road</li> </ul>	<ul style="list-style-type: none"> <li>Install curbing on Tower Hill Road as a more permanent solution to prevent southbound vehicles from passing using the shoulder</li> <li>Narrow the width of Annaquaticket Road at the intersection with Tower Hill Road with curbing</li> <li>Evaluate existing driveway locations and consolidate driveways where feasible for improved access management, coordinating with property owners</li> </ul>	<ul style="list-style-type: none"> <li>Consider the feasibility of implementing a road diet on Tower Hill Road, including separated space for people walking and biking, enhancing safety and connectivity for vulnerable road users while serving as a traffic calming tool to slow vehicle speeds</li> </ul>

Safety Issue	Potential Safety Enhancement	Time Frame	Safety Payoff	Cost	Responsible Party
<b>Intersection/Roadway Geometry (continued)</b>	Narrow the width of Annaquaticket Road at the intersection with Tower Hill Road using paint and/or flexible delineator posts to ensure only one vehicle turns onto Tower Hill Road at a time	Short-Term	Medium	Low	RIDOT / Town
	Advance the Town's plans to implement speed cameras for speed enforcement within the school zone on Annaquaticket Road	Short-Term	High	Low	Town
	Install curbing on Tower Hill Road as a more permanent solution to prevent southbound vehicles from passing using the shoulder	Mid-Term	High	Medium	RIDOT
	Narrow the width of Annaquaticket Road at the intersection with Tower Hill Road with curbing	Mid-Term	High	Medium	RIDOT / Town
	Improve access management on Tower Hill Road	Mid-Term	High	Medium	RIDOT
	Consider the feasibility of implementing a road diet on Tower Hill Road and construct if warranted	Long-Term	High	High	RIDOT

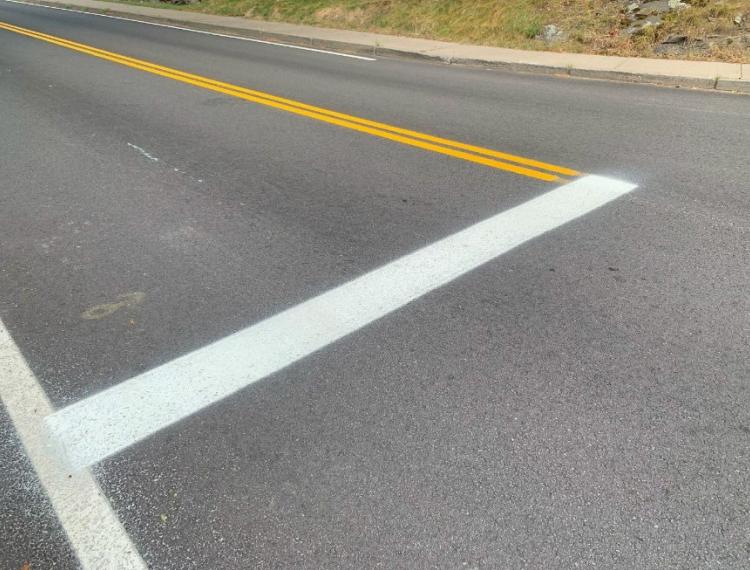
OBSERVATION	SHORT-TERM IMPROVEMENTS Under 6 months	MID-TERM IMPROVEMENTS Under 2 years	LONG-TERM IMPROVEMENTS Over 2 years
<p><b>Signage and Striping</b></p> <p>There are stop signs that could be upgraded at both stop-controlled intersections in the study area, due to the size of the signs and their limited retroreflectivity.</p> <p>Annaquaticket Road was recently re-paved and re-striped, including centerlines, stop bars, and edge lines.</p>

<p><i>Newly striped stop bar at the Fairway Drive intersection</i></p> <p>The crosswalk on Fairway Drive could be enhanced with higher visibility continental style striping and retroreflective paint.</p> <p>There is a need for advanced warning signage for both stop signs and curves along Annaquaticket Road.</p> <p>There is a need for additional speed limit signs on Annaquaticket Road.</p> <p>When speed cameras and feedback signs are installed along Annaquaticket Road, additional signage will need to be placed strategically to avoid excessive signage.</p>	<ul style="list-style-type: none"> <li>Repaint the existing crosswalk across Fairway Drive with high visibility and durable thermoplastic paint</li> <li>Replace existing stop signs with 36" signs with increased retroreflectivity, and ensure they are placed at appropriate height per the latest edition of the Manual on Uniform Traffic Control Devices (MUTCD)</li> <li>Install advanced stop warning signage on Annaquaticket Road approaching Tower Hill Road and Boston Neck Road</li> <li>Install chevron signs and/or flexible delineator posts along the horizontal roadway curves on Annaquaticket Road (between Fairway Drive and Lantern Lane, and between Barolay Drive and Clover Court)</li> <li>Install additional speed limit signs along Annaquaticket Road</li> </ul>	<p>N/A</p>	<p>N/A</p>

<b>Signage and Striping</b>	Repaint the existing crosswalk across Fairway Drive with high visibility and durable thermoplastic paint	Short-Term	Low	Low	Town
	Replace existing stop signs with 36" signs with increased retroreflectivity, and ensure they are placed at appropriate height per MUTCD	Short-Term	Low	Low	Town
	Install advanced stop warning signage on Annaquaticket Road	Short-Term	Medium	Low	Town
	Install chevron signs and/or flexible delineator posts along horizontal roadway curves on Annaquaticket Road	Short-Term	Medium	Low	Town
	Install additional speed limit signs on Annaquaticket Road	Short-Term	Low	Low	Town

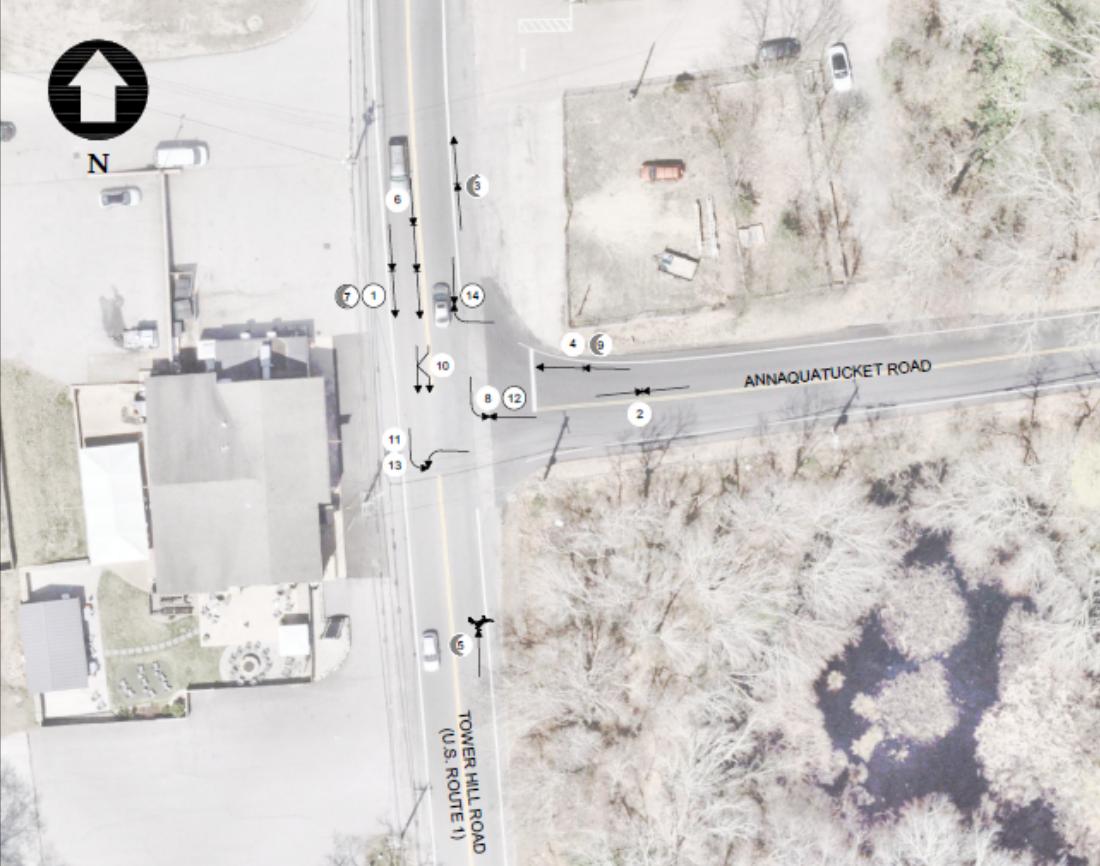
COLLISION DIAGRAM									
LOCATION	TOWER HILL ROAD (U.S. ROUTE 1) AT ANNAQUATUCKET ROAD								
	NORTH KINGSTOWN		STATE	RHODE ISLAND					
START SEGMENT	N/A		END SEGMENT	N/A

CRASH SUMMARY (5 YEAR TOTALS)									
PDO	INJURY CRASHES	FATAL CRASHES	TOTAL	NIGHT CRASHES	WET CRASHES				
10	4	0	14	4	1				
SYMBOLS		TYPE OF CRASH		SEVERITY					
→	MOVING VEHICLE	→→	HEAD ON	#					
←→	BACKING VEHICLE	→→→	REAR END	INJURY					
→→→	NON-INVOLVED VEHICLE	↓→↓↑	ANGLE	#					
PEDESTRIAN	INVOLVED	NOT INVOLVED	→	TURNING MOVEMENT	FATAL				
BICYCLE			→→	SIDESWIPE	#				
ANIMAL			→→→	OUT OF CONTROL					
PARKED VEHICLE			⌚	NIGHT TIME CRASH	PROPERTY DAMAGE ONLY				
FIXED OBJECT	□	□							
COLLISION DIAGRAM (2019-2023) ROAD SAFETY ASSESSMENT		TOWER HILL ROAD (U.S. ROUTE 1) AT ANNAQUATUCKET ROAD NORTH KINGSTOWN, RI		<b>Bowman</b>

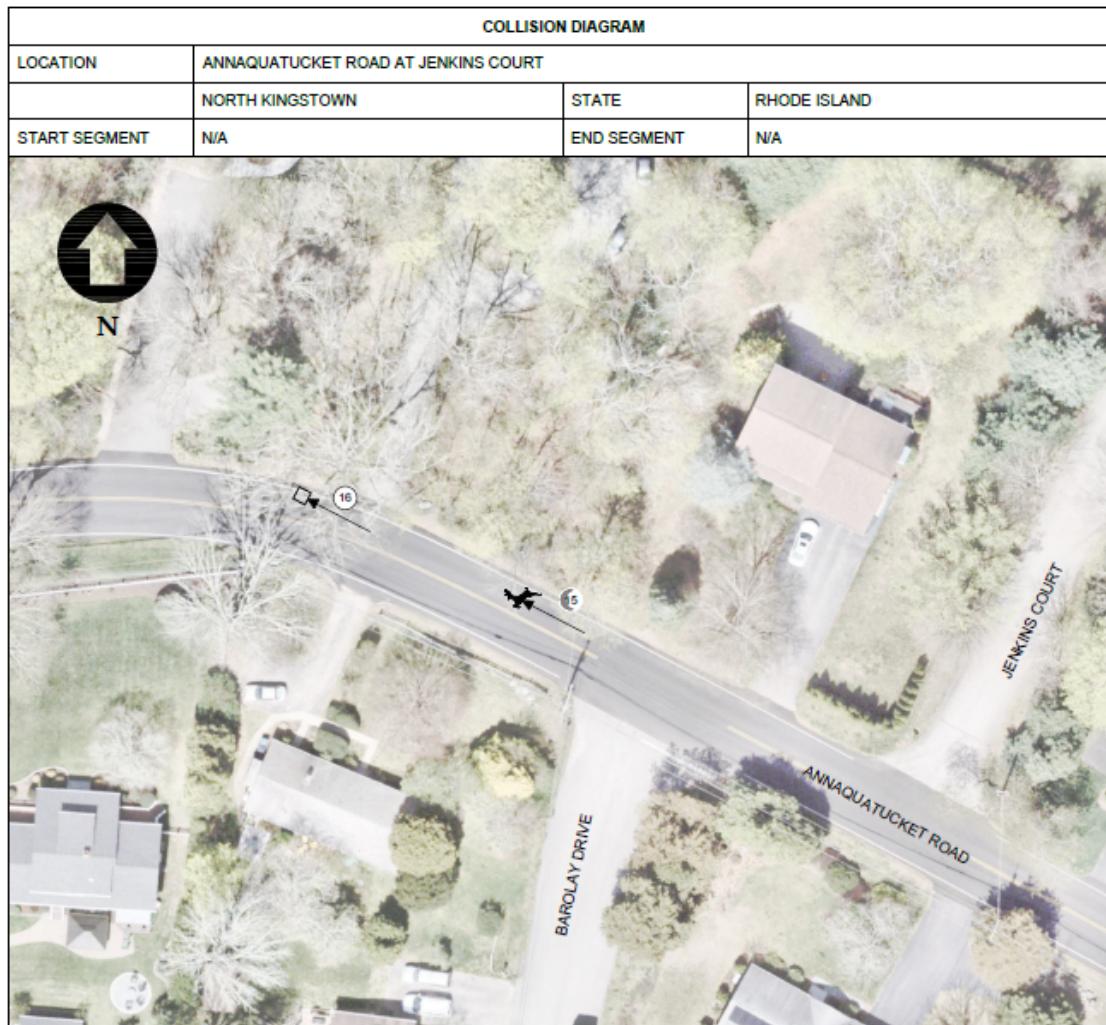
COLLISION DIAGRAM									
LOCATION	ANNAQUATUCKET ROAD AT JENKINS COURT								
	NORTH KINGSTOWN	STATE	RHODE ISLAND						
START SEGMENT	N/A		END SEGMENT	N/A

CRASH SUMMARY (5 YEAR TOTALS)									
PDO	INJURY CRASHES	FATAL CRASHES	TOTAL	NIGHT CRASHES	WET CRASHES				
1	1	0	2	1	0				
SYMBOLS			TYPE OF CRASH		SEVERITY				
→	MOVING VEHICLE		↔	HEAD ON	#				
←→	BACKING VEHICLE		→→	REAR END	INJURY				
→→→	NON-INVOLVED VEHICLE		↓→	ANGLE	#				
PEDESTRIAN	INVOLVED	NOT INVOLVED	→↓	TURNING MOVEMENT	FATAL				
BICYCLE	↔	↔	↔	SIDESWIPE	#				
ANIMAL			→→	OUT OF CONTROL	PROPERTY DAMAGE ONLY				
PARKED VEHICLE	↔	↔	↔	NIGHT TIME CRASH					
FIXED OBJECT	□	□							
COLLISION DIAGRAM (2019-2023)			ANNAQUATUCKET ROAD AT JENKINS COURT NORTH KINGSTOWN, RI		<b>Bowman</b>				
ROAD SAFETY ASSESSMENT

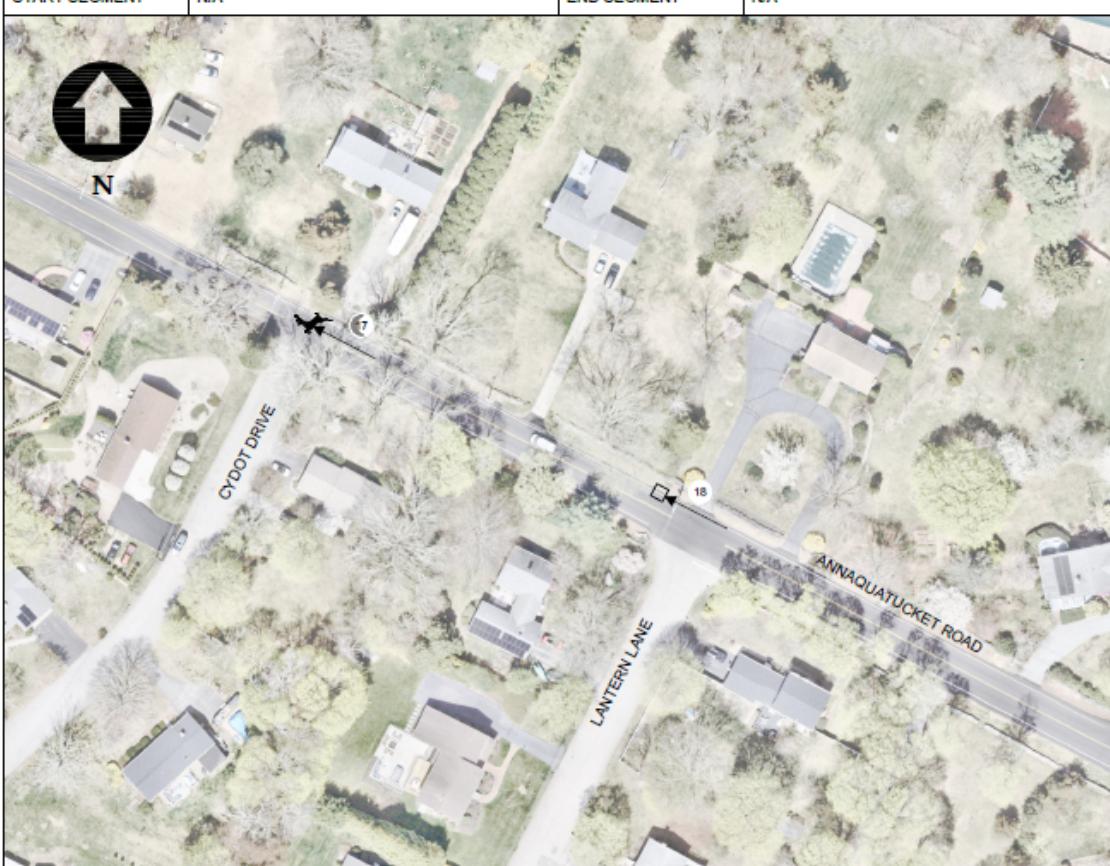
COLLISION DIAGRAM								
LOCATION	ANNAQUATUCKET ROAD AT CYDOT DRIVE/LANTERN LANE							
	NORTH KINGSTOWN	STATE	RHODE ISLAND					
START SEGMENT	N/A	END SEGMENT	N/A

CRASH SUMMARY (5 YEAR TOTALS)								
PDO	INJURY CRASHES	FATAL CRASHES	TOTAL	NIGHT CRASHES	WET CRASHES			
2	0	0	2	1	0			
SYMBOLS		TYPE OF CRASH		SEVERITY				
→	MOVING VEHICLE	→	HEAD ON	#				
←→	BACKING VEHICLE	→	REAR END	INJURY				
→→	NON-INVOLVED VEHICLE	↓→	ANGLE	#				
INVOLVED	NOT INVOLVED							
PEDESTRIAN

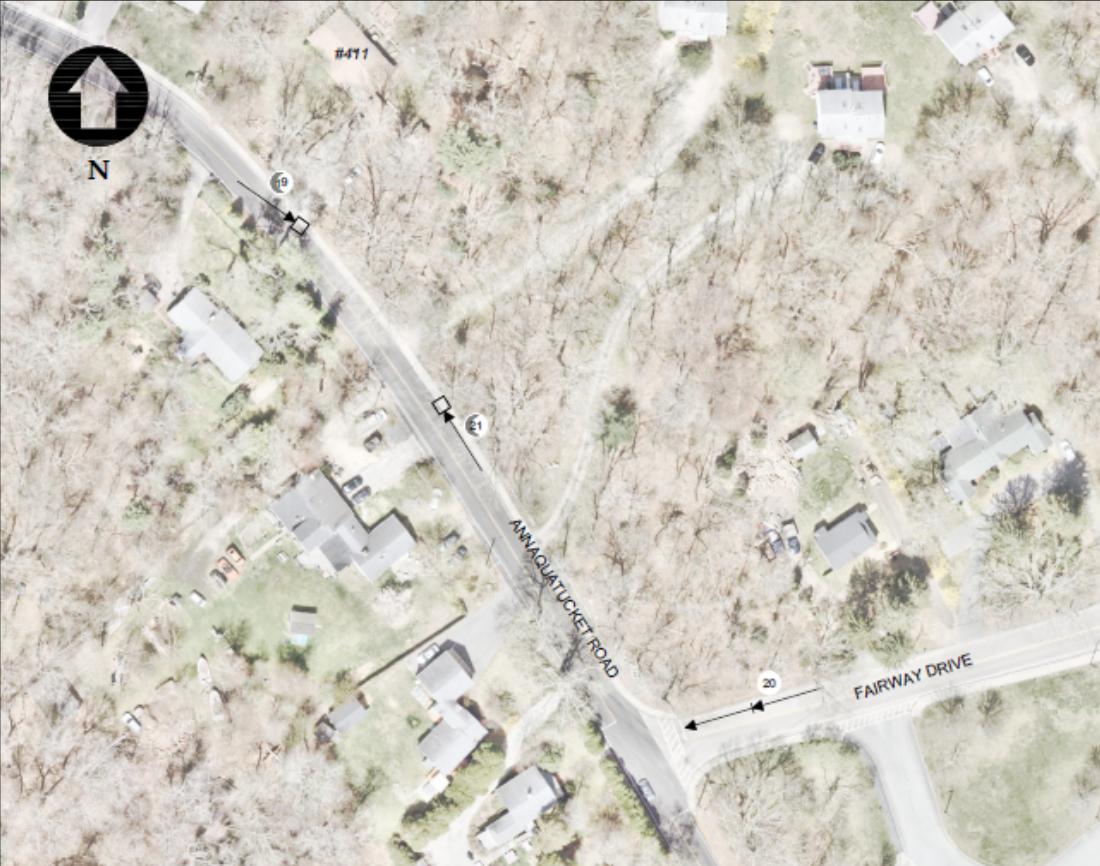
COLLISION DIAGRAM									
LOCATION	ANNAQUATUCKET ROAD AT FAIRWAY DRIVE								
	NORTH KINGSTOWN	STATE	RHODE ISLAND						
START SEGMENT	N/A		END SEGMENT	N/A

CRASH SUMMARY (5 YEAR TOTALS)									
PDO	INJURY CRASHES	FATAL CRASHES	TOTAL	NIGHT CRASHES	WET CRASHES				
3	0	0	3	2	0				
SYMBOLS		TYPE OF CRASH		SEVERITY					
→	MOVING VEHICLE	→→	HEAD ON	#					
←→	BACKING VEHICLE	→→	REAR END	INJURY					
→→	NON-INVOLVED VEHICLE	↓→ ↓↑	ANGLE	#					
INVOLVED	NOT INVOLVED	→	TURNING MOVEMENT	FATAL					
PEDESTRIAN

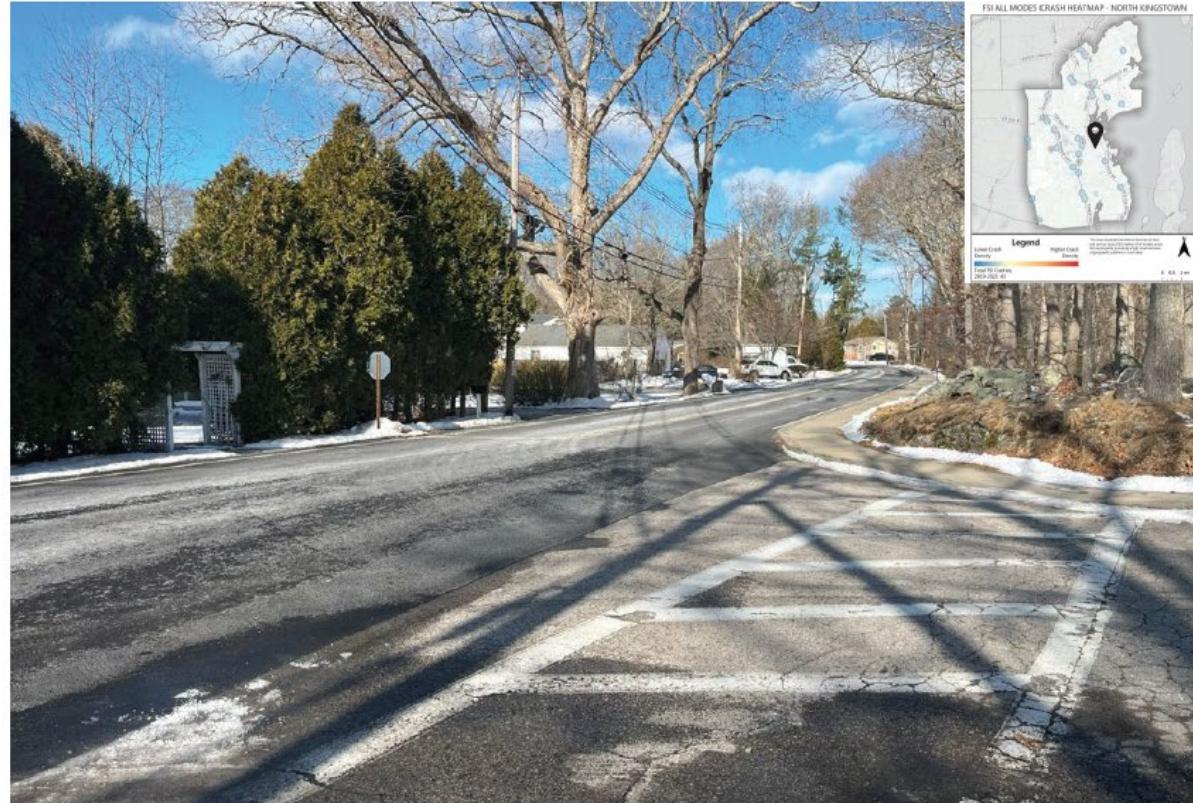
### Key observations:

- Need for improved crosswalk across Fairway Drive
- Need for improved signage, including stop signs and advanced warning signage
