ROAD SAFETY ASSESSMENT

STONY LANE AT OLD BAPTIST ROAD
NORTH KINGSTOWN, RI

Prepared by
Bowman Consulting Group, Ltd.
24 Albion Road, Suite 310
Lincoln, RI 02865

SEPTEMBER 2025

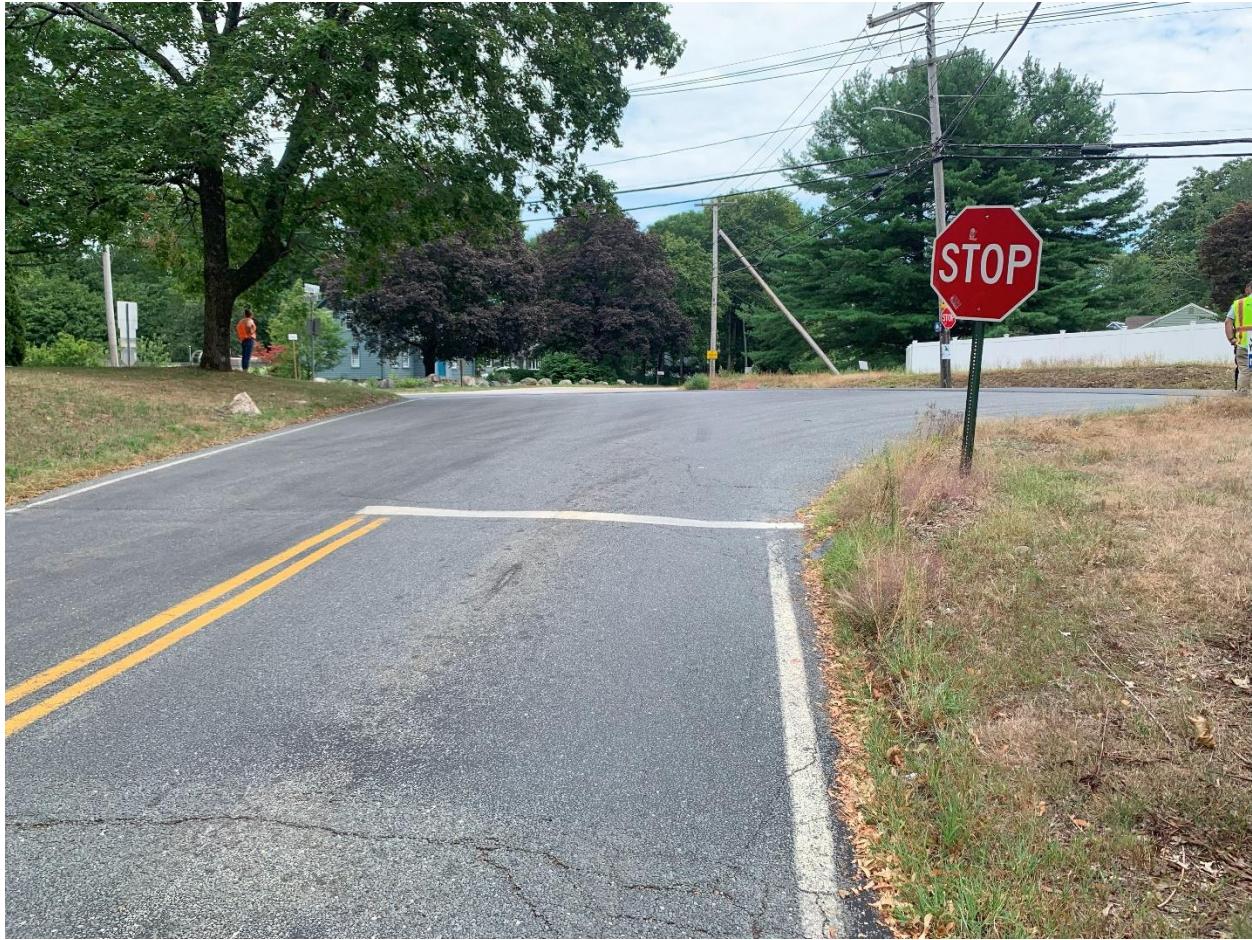
Stony Lane is classified as a major collector running east-west from North Kingstown's border with Exeter to Huling Road (adjacent to Post Road), with one travel lane in each direction. The Stony Lane approaches to Old Baptist Road consist of one general purpose lane. The posted speed limit is a school zone 20 miles per hour (mph) on the eastern side of the intersection and 25 mph west of the intersection. There are no sidewalks along the road and minimal shoulders on either side. The road is striped with double yellow center lines and white edge lines (fog lines). Stony Lane Elementary School is approximately two tenths of a mile east of the intersection. The land use is residential along the corridor.

Stony Lane looking east through the intersection with Old Baptist Road.

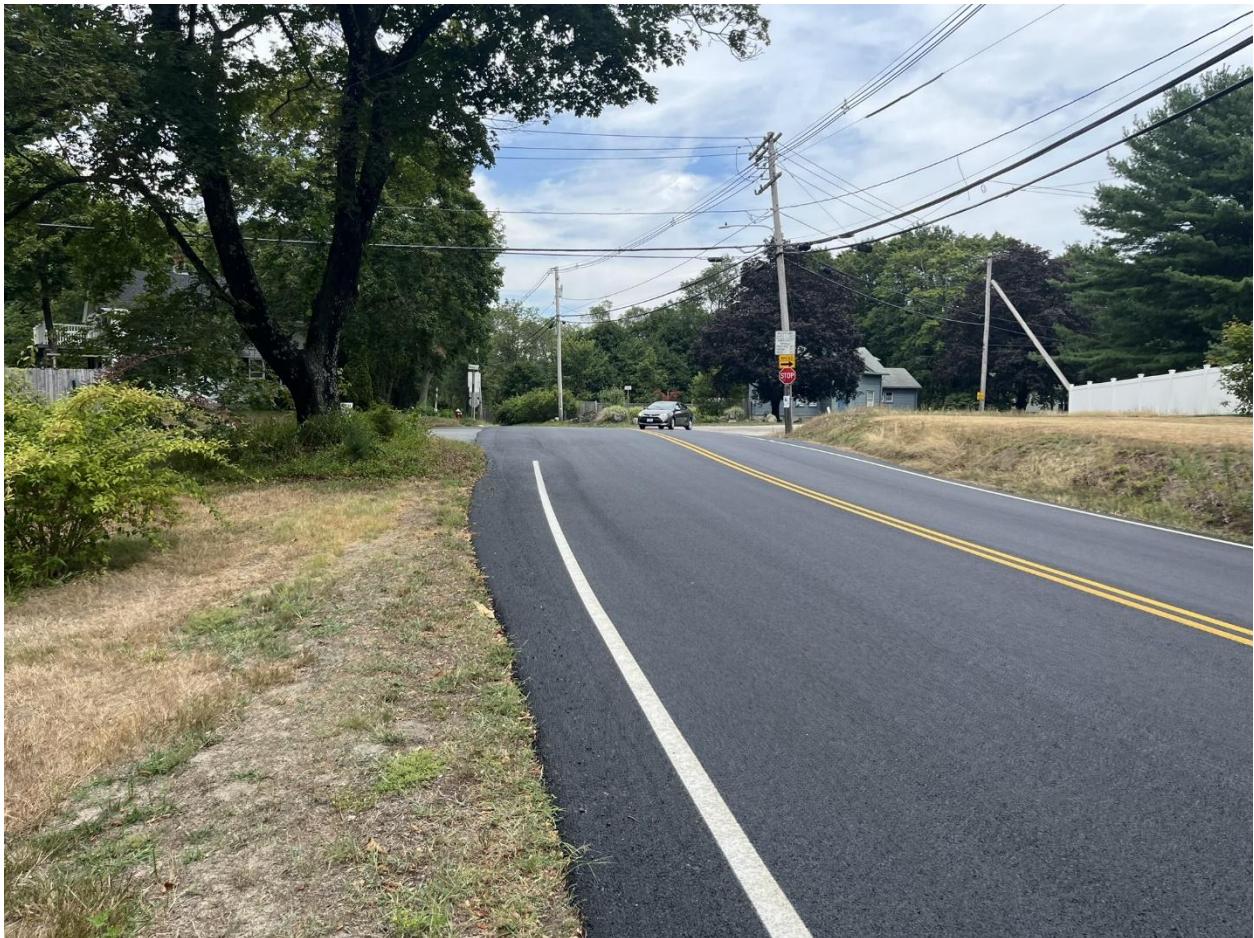
Old Baptist Road is classified as a local road that runs north-south from Davisville Road to Ten Rod Road (Route 102), with one travel lane in each direction. The Old Baptist Road approaches to Stony Lane intersection consist of one general purpose lane. The posted speed limit is 25 mph. There are no sidewalks along the road and minimal shoulder on either side. The road is striped with double yellow center lines and white edge lines (fog lines). The Stony Lane Church is approximately one tenth of a mile south of the intersection. The land use is residential along the corridor.

Old Baptist Road looking north through the intersection with Stony Lane.

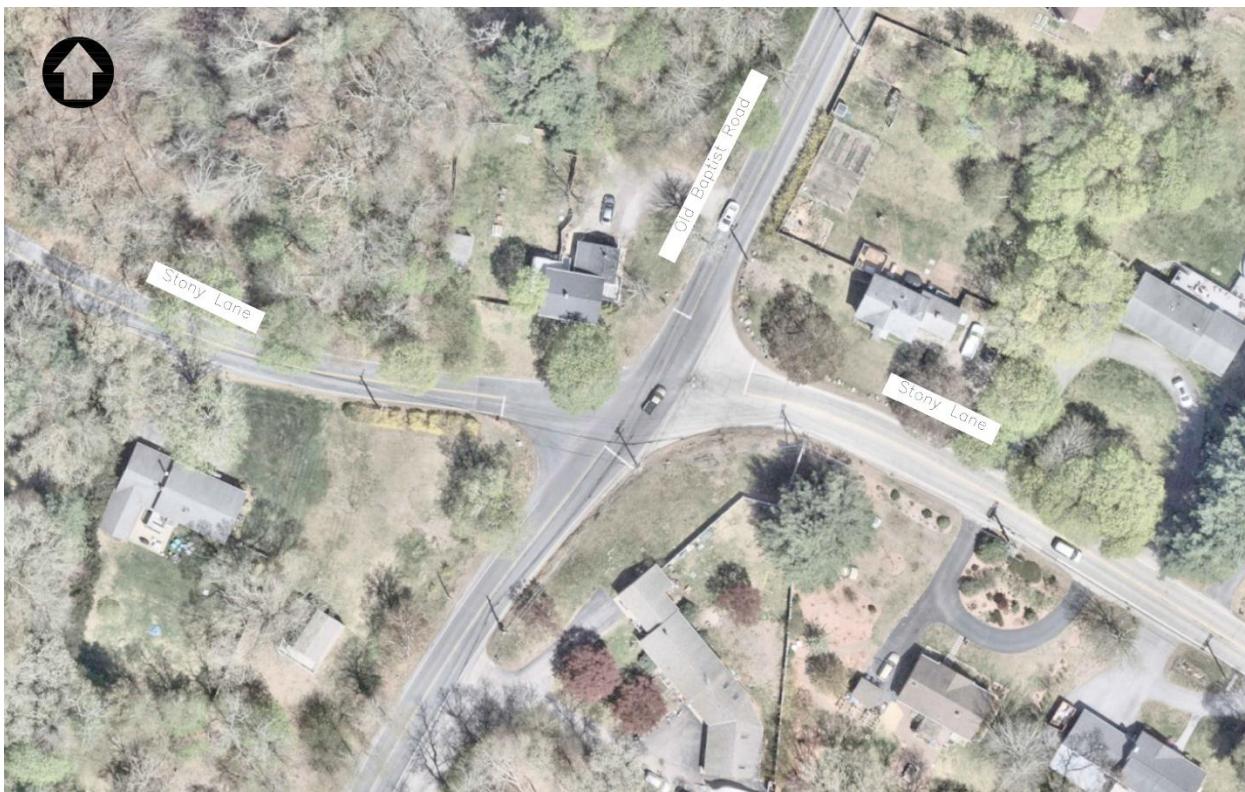
The all-way stop-controlled intersection of Stony Lane and Old Baptist Road is under Town of North Kingstown jurisdiction. There are no sidewalks, crosswalks, or curbing at the intersection. The intersection is utilized primarily by people making local trips, taking alternative routes between Ten Rod Road (Route 102) and Frenchtown Road (Route 402), and entering North Kingstown from South County Trail (Route 2). Although traffic volume data were not collected as part of this assessment, the RSA team observed constant vehicular traffic through the intersection. The intersection geometry is skewed so that the four legs of the intersection do not line up as in a traditional four-way intersection. The two approaches of Stony Lane are laterally offset, requiring vehicles traveling through the intersection to execute a reverse curve (S-shaped alignment) to proceed straight. Stop bars and stop signs are present on all four approaches. On the Old Baptist Road southbound approach and the Stony Lane eastbound approach, the stop bars are positioned further back from the intersection than on the remaining two approaches. This may be to accommodate large truck turns.

Aerial view of the Stony Lane at Old Baptist Road Intersection

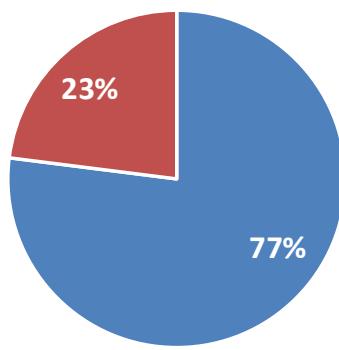
Figure 2: Crash Severity Summary for Study Area Intersections

The Town of North Kingstown Police Department provided crash data for the study area. A total of 13 crashes were reported at the study area intersection between 2019 and 2023. **Figure 2** summarizes crash severity. A total of 3 crashes (23%) resulted in personal injury, while the remaining 10 crashes (77%) had no reported injuries. **Figure 3** shows the various crash types. Angle collisions (12 crashes) were the most common crash type. The other crash was a rear-end collision that occurred on the Stony Lane eastbound approach to Old Baptist Road. All of the crashes that resulted in injuries were angle collisions, with two involving vehicles traveling eastbound on Stony Lane and southbound on Old Baptist Road, and the other angle crash location unknown.

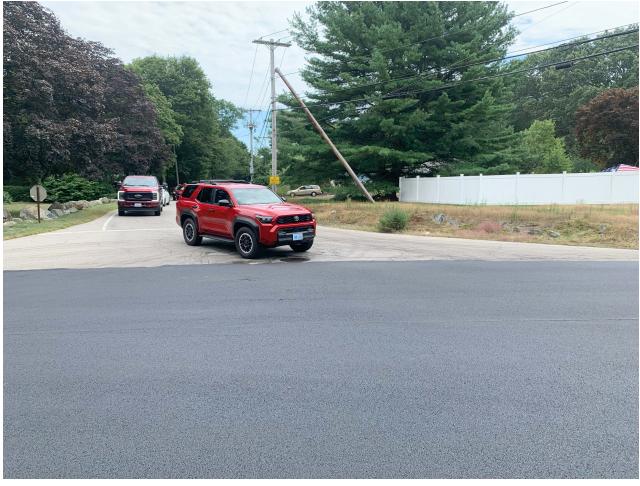
OBSERVATION	SHORT-TERM IMPROVEMENTS Under 6 months	MID-TERM IMPROVEMENTS Under 2 years	LONG-TERM IMPROVEMENTS Over 2 years
<p>Pedestrian Facilities and Accommodations</p> <p>There are no sidewalks or crosswalks at the intersection. RSA Team members stated that not many people walk in the area, although this could be due to the lack of safe facilities for walking.</p>

<p>Existing intersection geometry makes it difficult to navigate the intersection, especially for people outside of vehicles.</p>	<ul style="list-style-type: none"> Evaluate the feasibility of installing sidewalks along the northern side of Stony Lane from Old Baptist Road to Stony Lane Elementary School. Assess school drop-off and pick-up routines to determine if students and families walk to school. 	<ul style="list-style-type: none"> Install marked crosswalks along all approaches to the intersection, with curb ramps compliant with the Americans with Disabilities Act (ADA) guidelines on both sides of the crosswalks. 	<ul style="list-style-type: none"> Install sidewalks along the northern side of Stony Lane from Old Baptist Road to Stony Lane Elementary School.

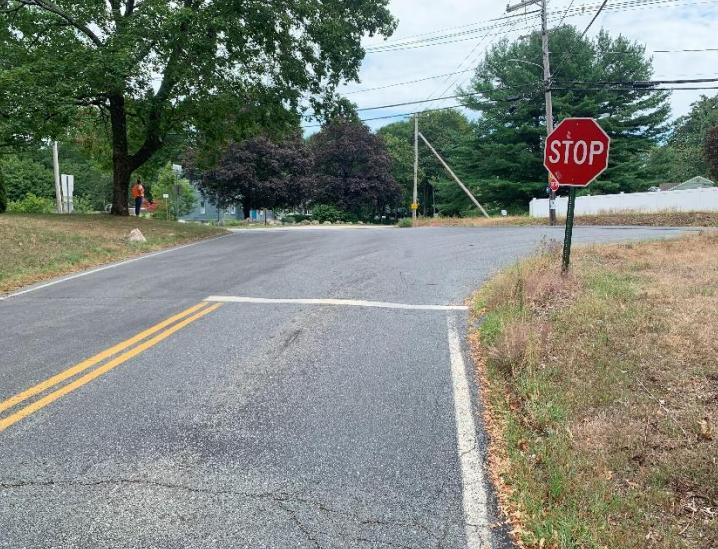
OBSERVATION	SHORT-TERM IMPROVEMENTS Under 6 months	MID-TERM IMPROVEMENTS Under 2 years	LONG-TERM IMPROVEMENTS Over 2 years
<p>Intersection/Roadway Geometry</p> <p>The intersection geometry limits sight distance along each approach, especially for people traveling along Stony Lane eastbound and Old Baptist Road southbound. This may have been a contributing factor in the angled crashes that occurred (crashes #4, #7, #9, #10, #12, and #13).</p>

<p>Sight lines are limited along the eastbound approach of Stony Lane, especially when looking for vehicles traveling southbound on Old Baptist Road.</p> <p>There are wide turning radii on the eastern Stony Lane leg of the intersection.</p> <p>Motorists often roll through the intersection in lieu of making a complete stop, especially when taking right turns from Old Baptist Road onto Stony Lane heading eastbound.</p>	<ul style="list-style-type: none">Evaluate curb-line modifications to reduce excessively wide turning radii and enhance sight distance on all approaches.Evaluate the types of heavy vehicles utilizing the intersection and ensure the curb-line modifications can accommodate the design vehicle.	<ul style="list-style-type: none">Implement a temporary pilot using water-based pavement markings and flexible delineator posts to simulate tighter intersection geometry. Coordinate with the Fire Department (for fire apparatus) and the School Department (for school bus movements) to test and confirm turning feasibility.	<ul style="list-style-type: none">If feasible based on Mid-term evaluation and pilot project, implement tighter intersection design with hardscape materials.

Assess drop-off and pick-up routines to determine if students and families currently bike to school or if there is a desire to bike to school.	Short-Term	Low	Low	Town
Intersection/Roadway Geometry	Evaluate curb-line modifications to reduce excessively wide turning radii and enhance sight distance on all approaches.	Short-Term	Low	Low	Town
	Evaluate the types of heavy vehicles utilizing the intersection and ensure the curb-line modifications can accommodate the design vehicle.	Short-Term	Low	Low	Town
	Implement a temporary pilot using water-based pavement markings and flexible delineator posts to simulate tighter intersection geometry. Coordinate with the Fire Department (for fire apparatus) and the School Department (for school bus movements) to test and confirm turning feasibility.	Mid-Term	High	Low	Town
	If feasible based on Mid-term evaluation and pilot project, implement tighter intersection design with hardscape materials.	Long-Term	High	High	Town

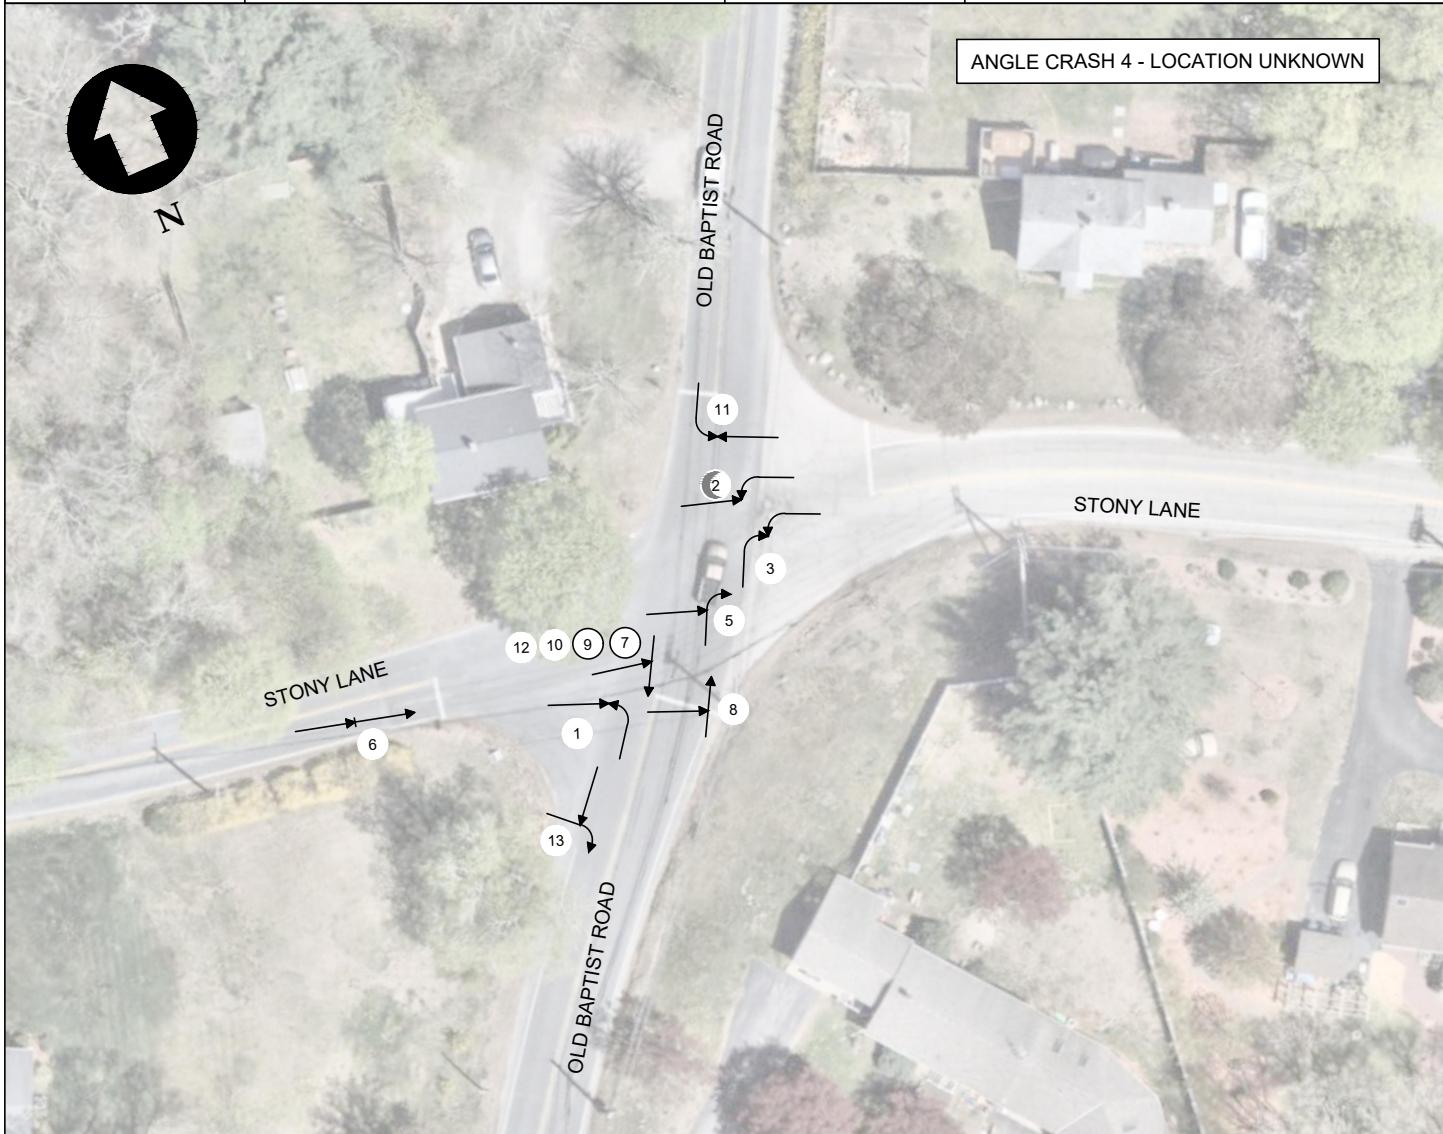
LOCATION	OLD BAPTIST ROAD AT STONY LANE		
	NORTH KINGSTOWN	STATE	RHODE ISLAND
START SEGMENT	N/A	END SEGMENT	N/A

PDO	INJURY CRASHES	FATAL CRASHES	TOTAL	NIGHT CRASHES	WET CRASHES
10	3	0	13	1	5
SYMBOLS			TYPE OF CRASH		SEVERITY
→ MOVING VEHICLE		↔ HEAD ON		#	
←→ BACKING VEHICLE		→→ REAR END		#	
→→→ NON-INVOLVED VEHICLE		↓↓→ ANGLE		#	
INVOLVED		NOT INVOLVED		#	
PEDESTRIAN

COLLISION DIAGRAM (2019-2023) ROAD SAFETY ASSESSMENT
